CARMEL MISSION FOUNDATION

Carmel Mission Basilica Restoration Report June 2013

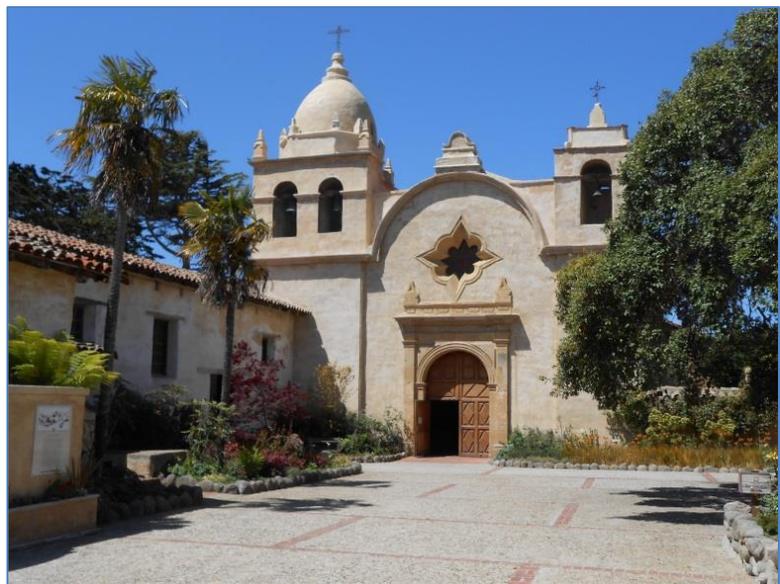
Newly restored Carmel Mission Basilica – June 2013

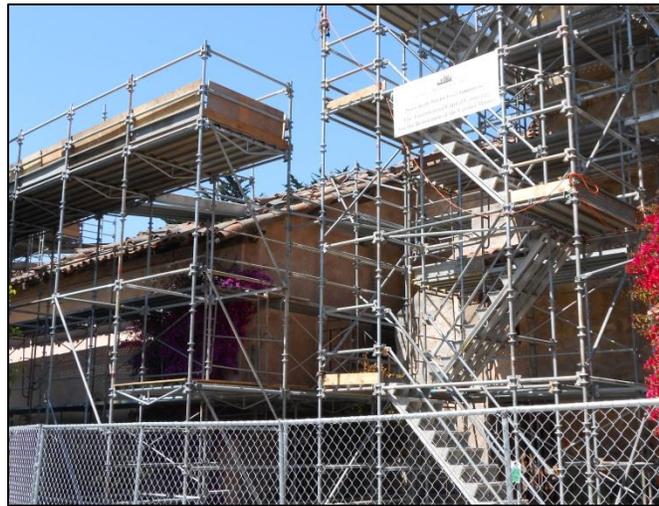
Scaffolding and tile platform on south side of Basilica

Basilica and constructing an entrance tunnel to provide safety for the public, while work was being performed overhead. Artifacts were wrapped for protection, and scaffolding was erected around the south, west, and north sides of the Basilica. Work on the east side, or front façade, was accomplished using a knuckle-boom lift, which was moved into place when needed. A

decision was made to store the removed roof tiles at roof level versus storing them on the ground in order to reduce labor and breakage. As a result, two elevated storage platforms were erected, one on the south side, and one on the north side of the Basilica.

In September, the scaffolding and the roof tile storage platforms were completed. Roof tiles were then removed and stored on the platforms. Concurrently, horizontal core drilling on the west buttresses commenced.

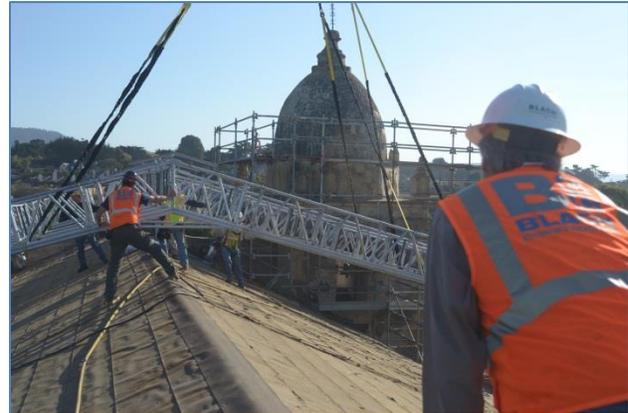
Installing weather protection structure over Basilica

Because of the uncertainty of the five-month weather window, it was decided by the team to erect a weather protection structure, which would completely cover the top of the Basilica. Though this would be expensive, it would allow the project to commence in the fall of 2012, versus waiting until the spring of 2013. Furthermore, having this protection over the top of the Basilica would mean that work could continue into the winter on a daily basis, regardless of weather conditions, while the ceiling would remain protected. Factoring in

the loss of productivity due to having to cover and uncover the roof daily with tarps, plus delays due to weather, the weather protection structure was considered a cost effective and prudent alternative. The weather protection structure was erected in October on top of the existing scaffolding and anchored to the ground by heavy cement K-rails, used for vehicle traffic dividers, and by the weight of the two tile storage platforms.

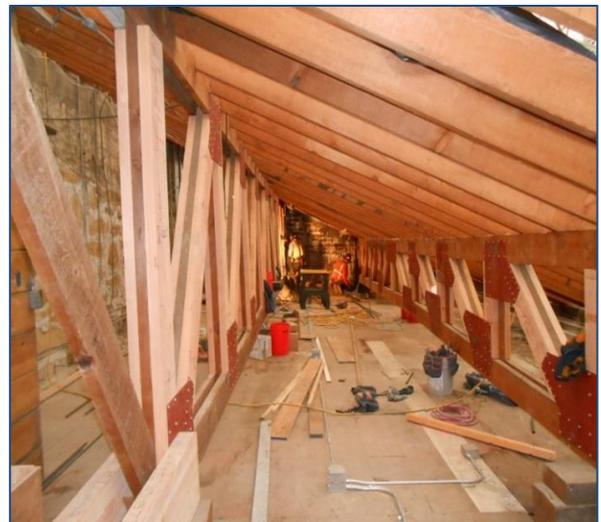
Strengthening roof trusses above the sacristy

October also saw the start of roof strengthening work with the removal of the old Douglas fir roof sheathing. However, not all sheathing could be removed at the same time, as it could destabilize the walls of the Basilica. Using new laser imaging technology, measurements had been earlier obtained in the attic, thus allowing many of the new wooden beams and metal collector plates used for strengthening the roof to be precut or prefabricated. Meanwhile, electricians started working to replace the Basilica's electrical system. Work also began on installation of the copper piping for the fire suppression system. Though copper was more expensive, it was chosen to provide a longer system life.

In December, drilling of the 300+ wall cores continued, as did seismic strengthening of the roof with installation of additional wood beams and metal plate collectors to strengthen trusses, wood blocking to separate and strengthen rafters, and metal plates to tie rafters to the walls. Once all work beneath the roof was completed, new roof sheathing installation could begin. Unlike the Douglas fir planks that had been removed, the new sheathing consisted of specially treated 4-foot by 8-foot plywood sections, which would better distribute lateral earthquake forces. In addition, work began on the new ADA restroom building.

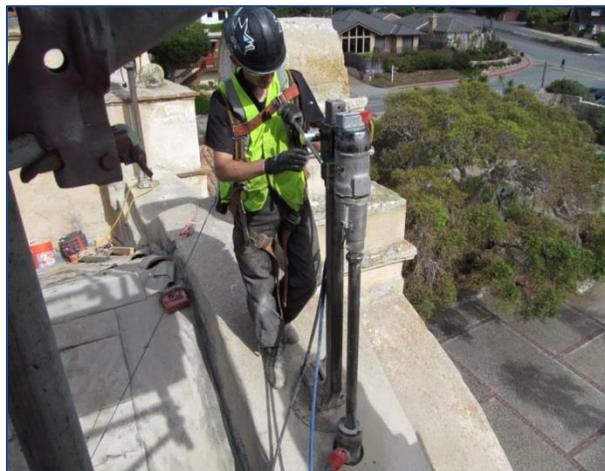
Core drilling on the front façade

November saw the installation of steel I-beams to better tie the Basilica structure together. The drilling of vertical cores into the walls was followed by inserting steel rods and grouting them into place. Installation of new electrical panels, plus conduits for electrical power, lighting, and fire alarm systems continued. The first phase of shotcrete (concrete conveyed through a hose at high velocity) bond beam installation began in order to strengthen certain portions of the Basilica's walls and towers.

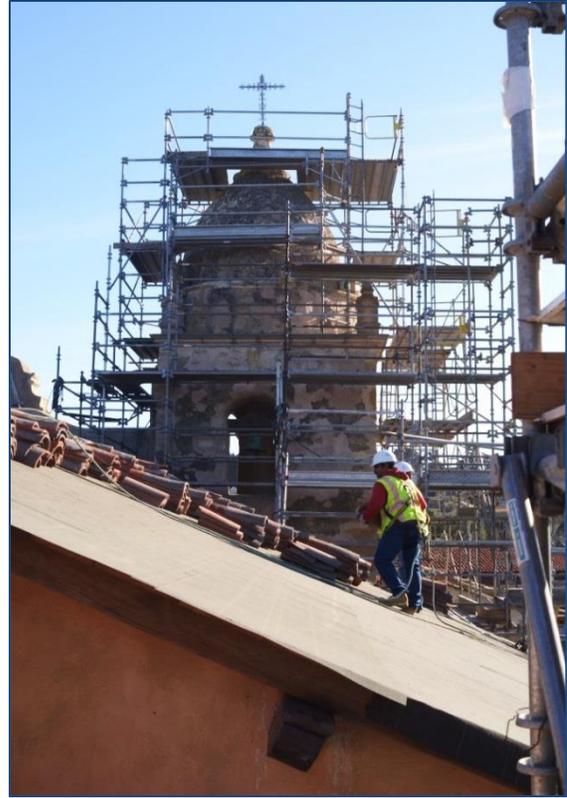
Reinstallation of roof tiles, while dome restoration is underway

In March, the roof tiles were reinstalled. Trenches were dug to bring in from the street the needed underground service and utilities to support the new restroom building and the Basilica fire suppression system. New ADA ramps were constructed and repairs were made to existing stairs and sidewalks to provide a safer and more accessible environment.

In April, exterior restoration work continued, shifting to the towers and dome, and new rain gutters were added. Inside, a new lighting system, together with new chandeliers, was installed. The chandeliers were custom made, based on images of chandeliers hanging in the Basilica during the 1940s. The old boiler for the radiant heating system was replaced with a new boiler, which reduced pressure, thus prolonging system life and increasing energy efficiency. By the end of April, most of the exterior scaffolding had been removed.
